OBSERVATION OF THE INITIATION AND PROGRESSION OF  
DAMAGE IN COMPRESSIVELY LOADED COMPOSITE PLATES  
CONTAINING A CUTOUT

**Progress report**

**Grant: NSG 1483**

**November 1986**

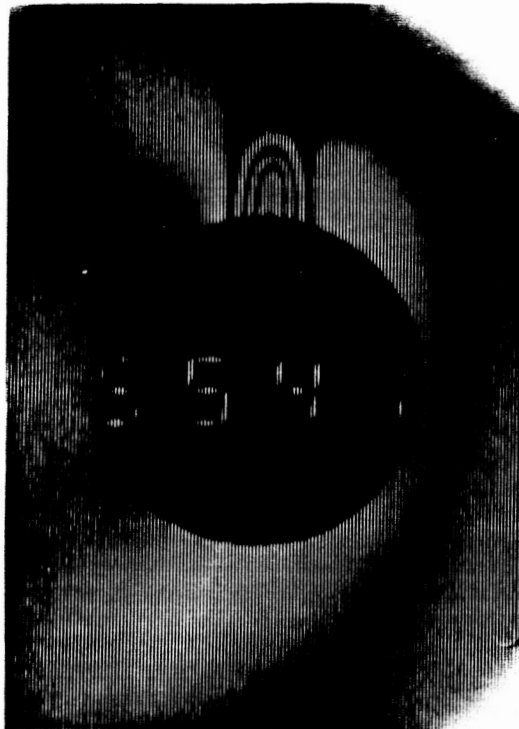
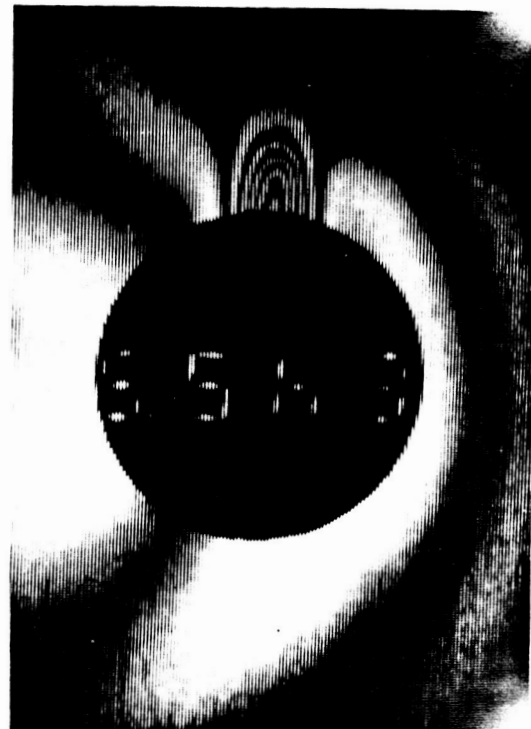
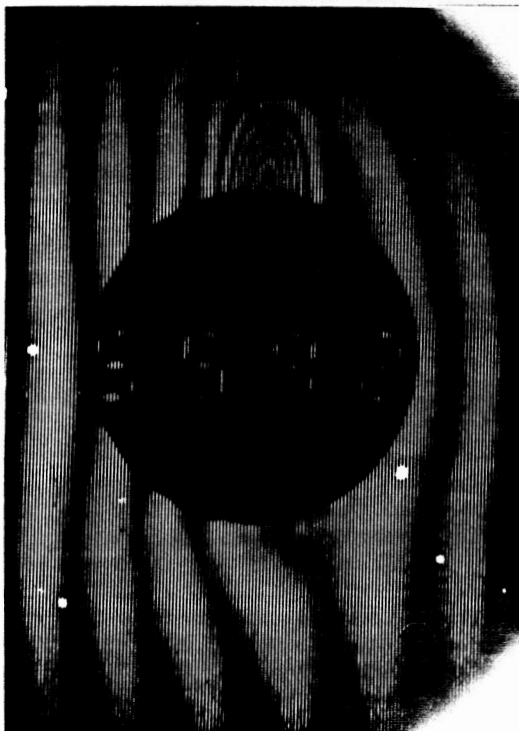
This type of specimen is one in which there are a fewer number of  $0^0$  plies (25%). Figure 14. shows a series of interferometric patterns, which correspond to the first instance at which internal damage was detected. The numbers below each picture represent the load in *lbf* ( $\times 4.448 \text{ N}$ ) corresponding to each frame, while  $P_h$  indicates the load at which the hologram was made (*Reference load*). Notice the highly localised fringe cluster adjacent to the hole edge at approximately  $90^0$  to the loading direction. When any form of internal damage occurs that manifests itself as a localised perturbation in the normal displacement component  $w$  the resulting interferometric patterns display this event as shown in the figure. A view of the hole surface corresponding to this fringe pattern is shown in frame 2 of Figure 15. Notice the damage to the midplane  $0^0$  plies which appear as a black spot. Adjacent to this spot is a delamination crack. Inspection of the photomicrographs prior to this event revealed no damage to the hole surface. In all tests it was revealed that *always* a *perturbation* in the *Interferometric data* corresponded to  $0^0$  *ply damage at the hole surface*. We interpret this interferometric pattern as a localised bulging of the surface just above the damage site. This localised damage to the  $0^0$  plies is found to be the triggering of extensive delamination cracking and buckling. The above sequence of events is consistently observed in all of the Type B specimen. At this stage we point out that when we refer to damage we mean the destruction to the specimen caused by the application of mechanical load as picked up on the interferograms. The interferograms corresponding to the initiation event reveal the displacements within the damage zone to be increasing with increasing

load. This is clear by noting a sharp increase in the fringe density within the damage zone as loading proceeds. Subsequent to the initiation, the remaining  $0^0$  layers undergo failure while delaminations are seen to appear between various ply interfaces. An inspection of the sequence of photomicrographs in Figure 15 shows this. The delaminations undergo a stage of slow growth as shown in the next set of interferometric patterns (Figure 16). Here the reference state corresponds to a load  $P_h = 35,760 \text{ lbf}$  (159 kN) while the three frames span a load increase,  $\Delta P$  of 390 lbf (1.73 kN). The displacement patterns corresponding to this figure are shown in Figure 17. Here the displacements are measured with respect to displacements in areas remote from the hole edge. The origin of the axes is placed at the edge of the hole as indicated. The X and Y axes are scaled while the vertical axes representing  $\Delta w$  is 1:1. The fringe patterns reveal the displacements to be growing faster within the damage zone than the rest of the specimen. Further the damage area is also growing. The corresponding photomicrographs show the extent to which delamination cracking occur. Notice the zero fiber breaks as well as the large (on the order of a ply thickness) mode I type displacements. These observations lead us to believe that *Delamination Buckling* is the mechanism chiefly responsible for spreading of the damage to the undamaged areas of the plate. Once the delaminated portions reach a sizeable extent an increase in the growth rate is noticed. This is shown in the last series of interferograms (Figure 18). In these the fringe density within the damage zone is very high, so much so, that the resolution of the interferogram within this area is poor. However the manner in which these delaminations grow and respond can be deduced by following the fringe development within the damage area. This will be discussed later in the context of Type A specimen. It must be pointed out that playback of the recorded video information displays a continuous transition in the fringe data which enables following the damage

Figure 14. Initiation of damage.  
(Spec. TB 11)

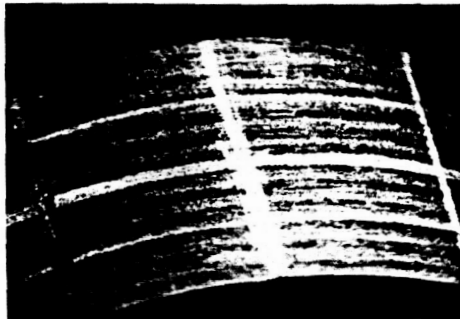
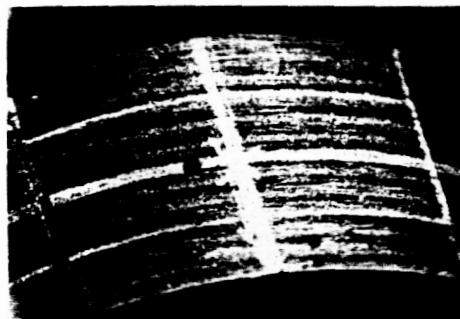
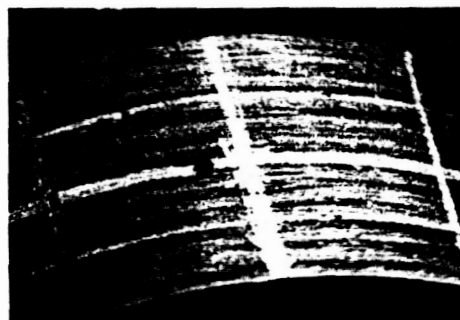
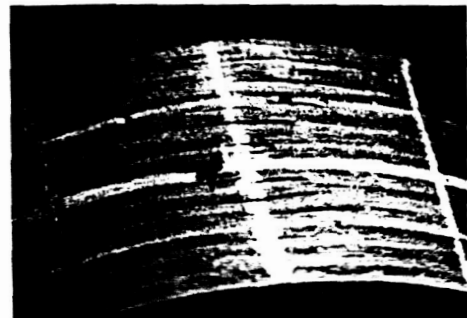
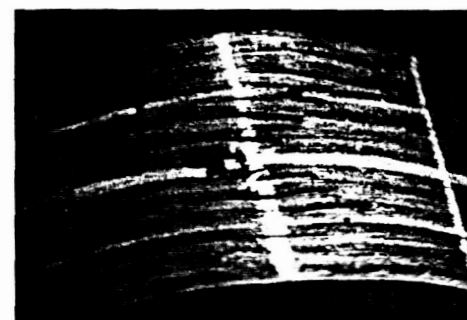
Figure 15. Hole surface photomicrographs  
(spec. TB II)

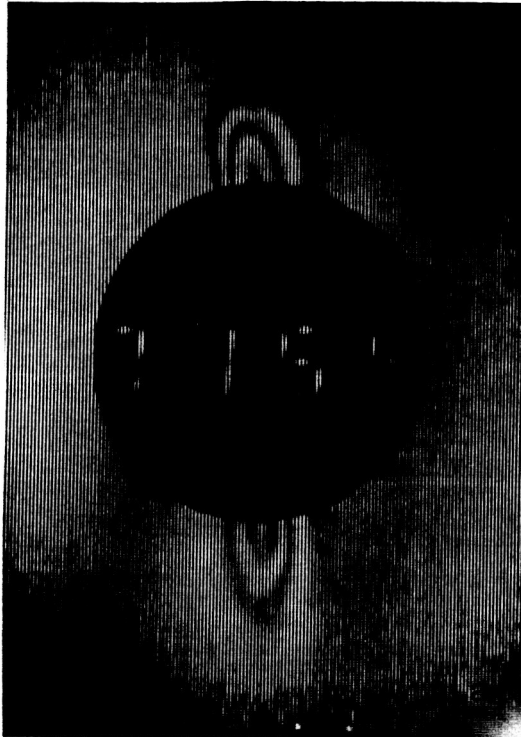
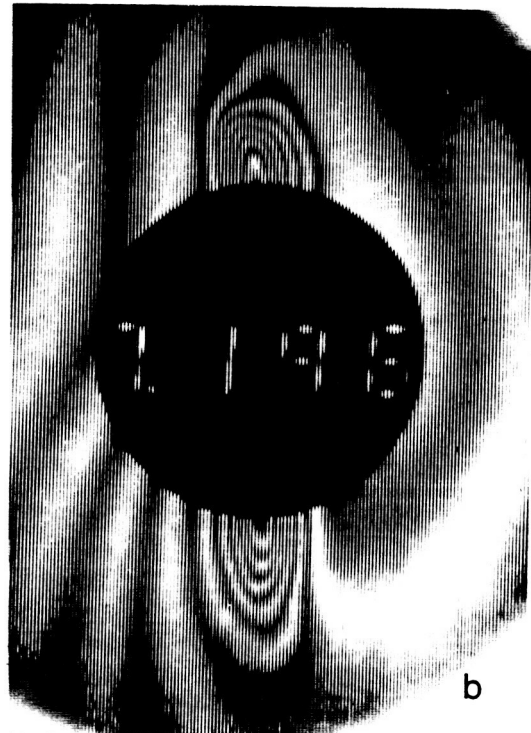
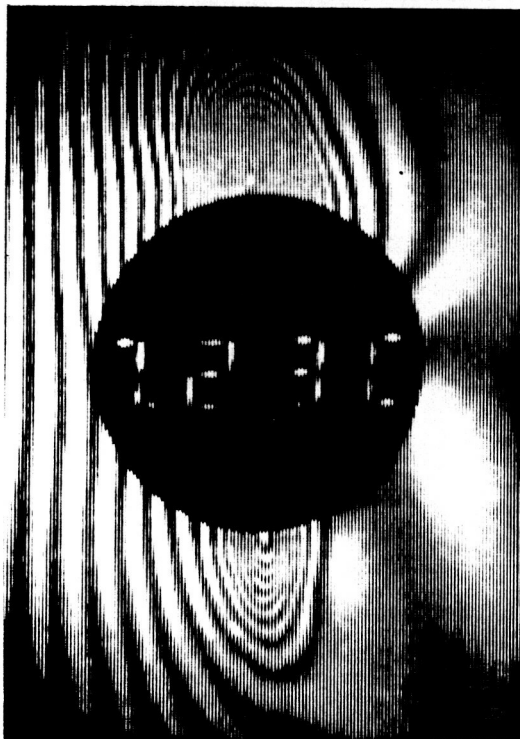
Figure 16. Buckling and spreading  
of delaminated portions.  
(Spec. TB11)

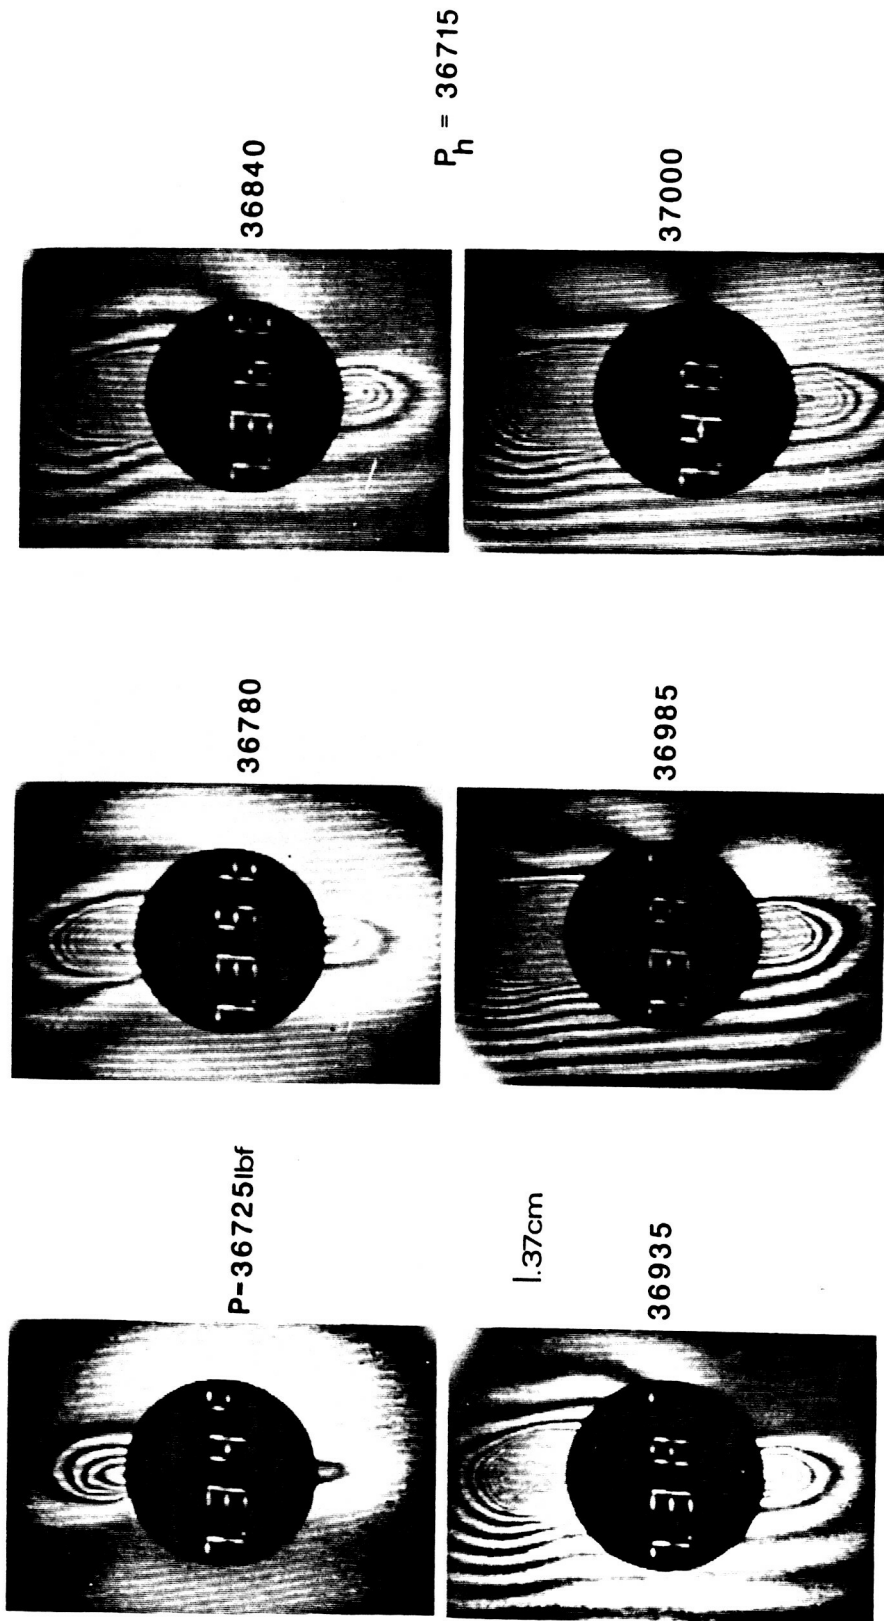
Figure 18. Buckling and spreading of delaminated portions just prior to catastrophic failure.

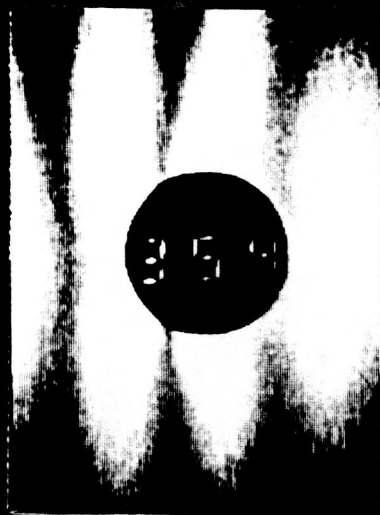
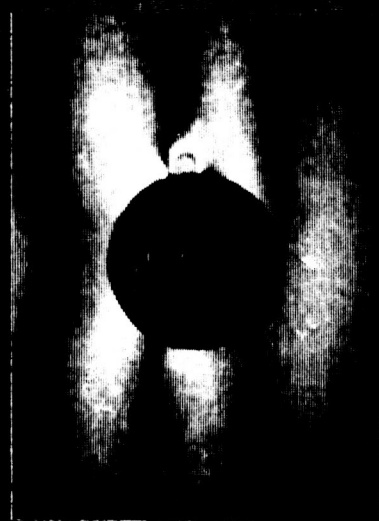
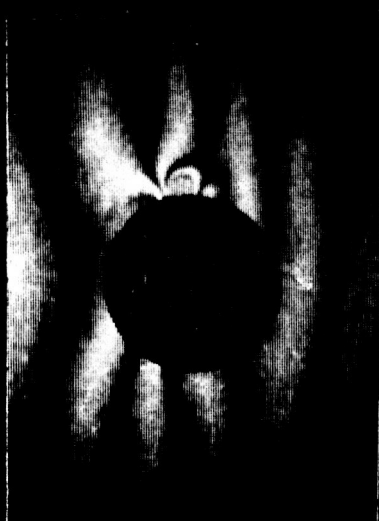
Figure 19a. Fringe pattern at damage initiation. Spec TB18

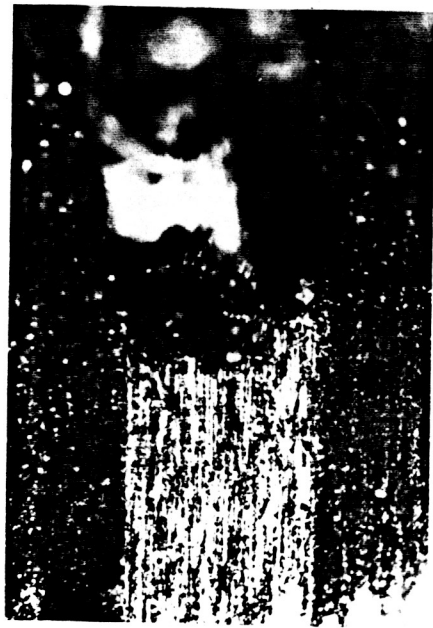
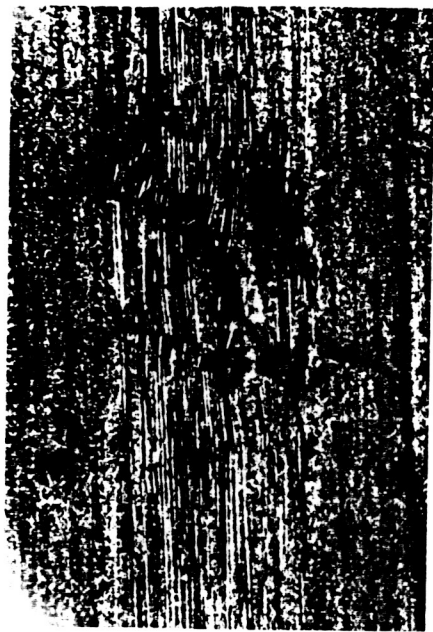
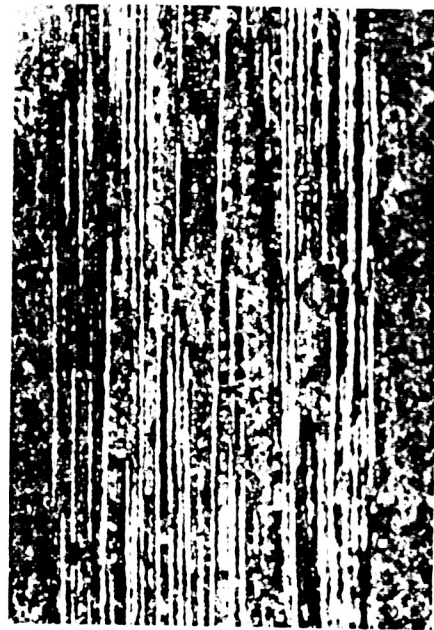
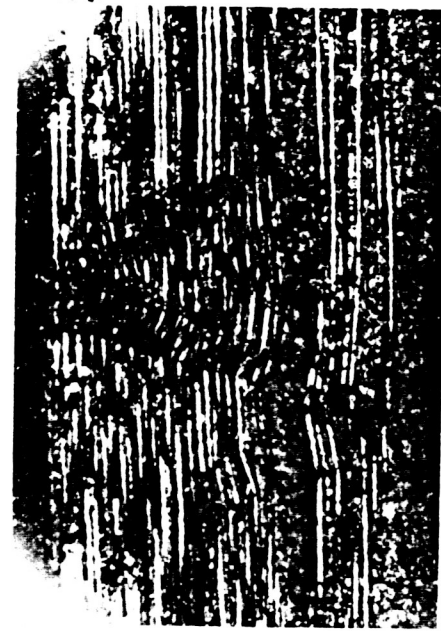
Sectioning beyond cross-section "D" and inspection under the microscope revealed no further damage. Similar inspection to other specimen loaded to levels just prior to catastrophic failure revealed that the damage zone was contained within one hole radius.

Figure 20. Surface/Internal damage to spec. TB II at different sections

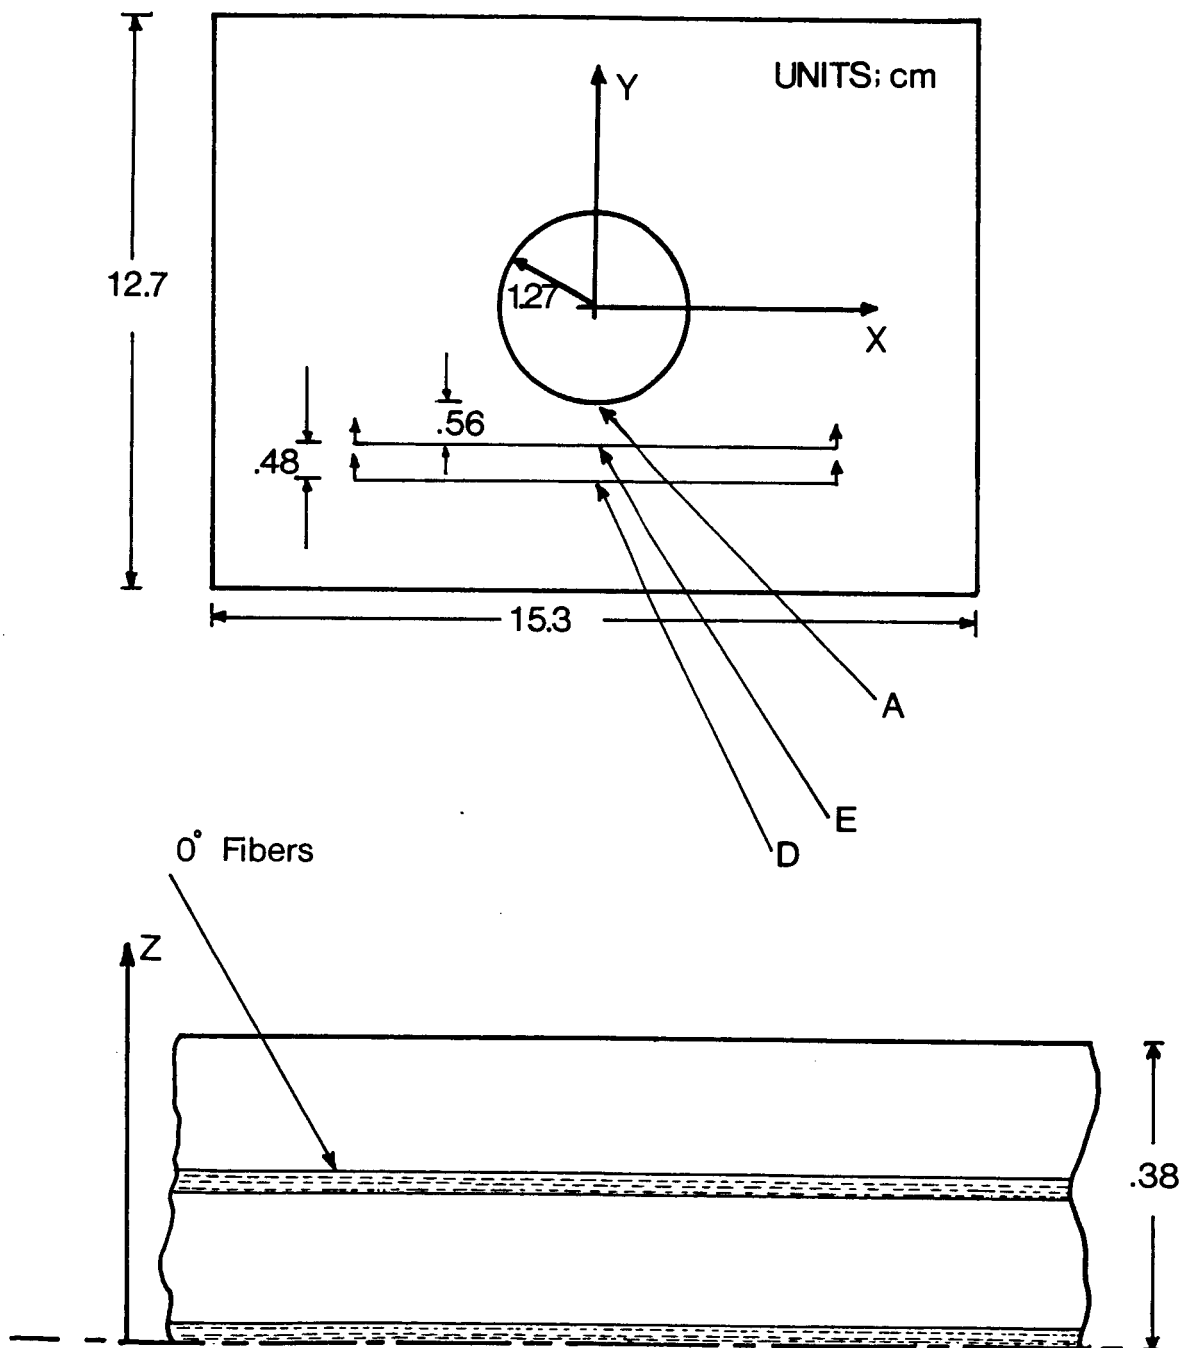
Next, we turn to a discussion of post experiment microscopic studies. It was felt that the  $0^0$  ply damage observed in the preceeding section warranted further examination. As such, some specimen were loaded into the post initiation level but unloaded prior to catastrophic failure. In particular the specimen whose interferometric results were discussed earlier, was unloaded near its ultimate failure load and sectioned for further study. An enlarged view of the black spot appearing in the photomicrographs is shown in "A" of Figure 20. Notice that a part of the picture is out of focus. This is because the fibers in that region have juttred out of the plane of the hole surface (plane of the picture). Examination of similar damage to other  $0^0$  layers revealed the same type of jutout failure. It was also of interest to determine the extent to which the hole surface damage propagated into the interior of the specimen. The laminate was sectioned at different locations as indicated in Figure 21. Magnified views of the  $0^0$  layers at sections "E" and "D" are shown in Figure 20 & 22. Notice the dark regions showing broken fiber segments scattered at different angles. In "D" an undamaged portion of the midplane  $0^0$  layer is shown contrasted against a damaged portion which clearly indicates a characteristic pattern. Here we see a V shaped matrix rich area, within which the fibers have undergone rotations. The maximum width of the V shaped zone measures to be approximately 0.3 mm. The matrix rich portion in the bottom right hand picture is seen inclined at an

angle of  $65^\circ$  to the  $0^\circ$  fiber direction. These characteristic patterns of failure have collectively been referred to as *Fiber kinking* in the literature.

Figure 21. Post-experiment microscopic examination (TB 11)

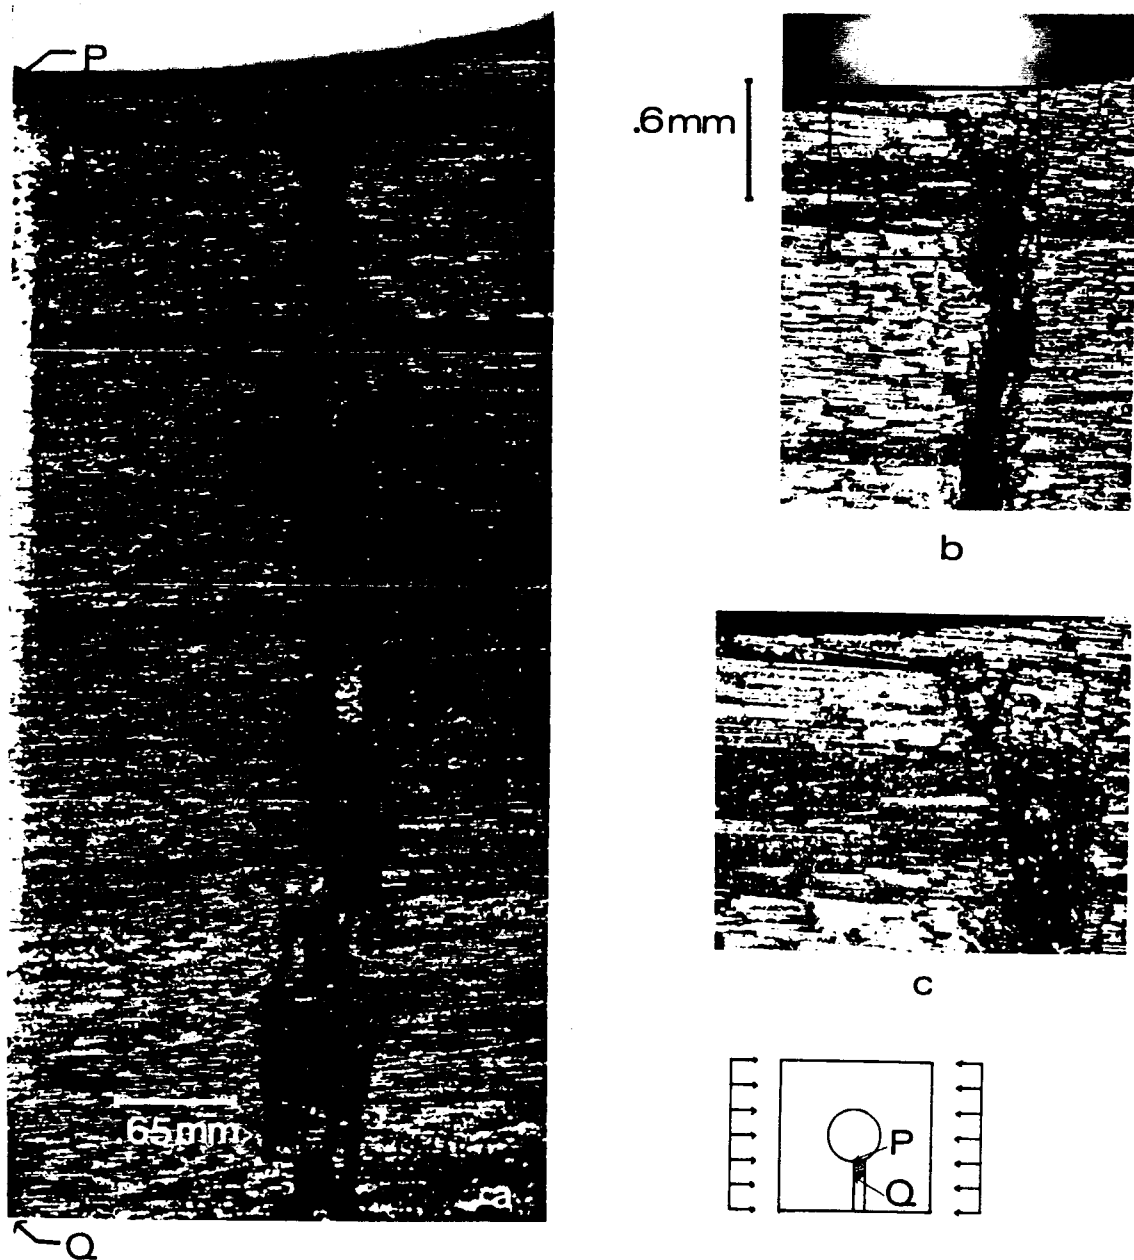
Planform views of the damaged midplane  $0^\circ$  layer as obtained by mechanical polishing is shown in (a) of Figure 23. Here we note the matrix rich damage zone which measures in width to approximately 70 fiber diameters (0.5 mm). Closer examination of the edge of the damage zone revealed that the fibers had undergone rotation in the plane of the picture. Thus, in this zone the fibers have not only undergone rotations in the  $XY$  plane, but also in the  $XZ$  plane as indicated by the sectioning studies earlier. Similar results were obtained from the deplying study which consists of heating the damaged samples to about  $600^\circ\text{F}$  and removing ply by ply to observe internal damage. Shown in Figure 24a is a C-scan of a specimen loaded upto about 90% of its failure load. This scan is a planform view of the integrated through thickness damage. Here we note the clear resemblance between the shape of the damaged area and the portion of the interferometric patterns that contain a very high fringe density.

Figure 23. Planform view of internal damage to 0° layers.  
a) mid plane 0° layer (TB11). b) second from bottom 0° layer (TB17).  
c) inset of (b).

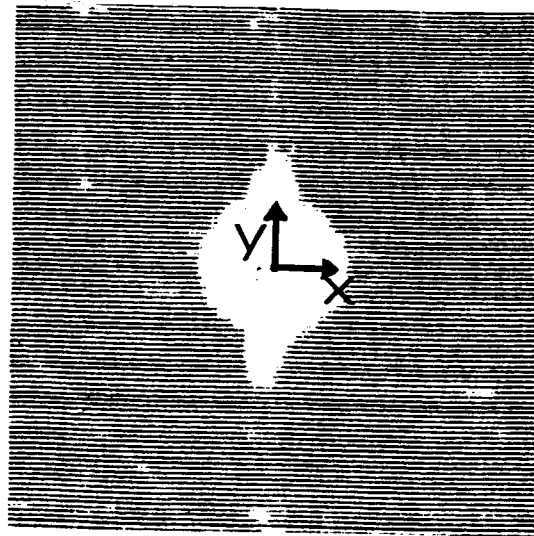
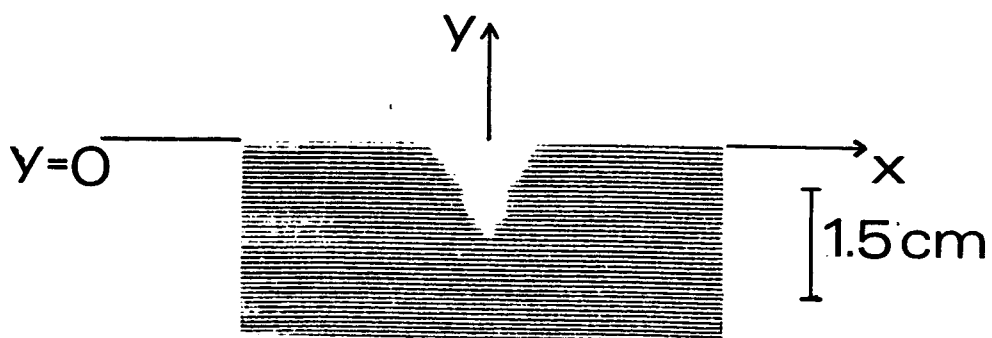
Bearing in mind the information obtained from the surfaces of the specimen, we now turn to a discussion of post experiment sectioning studies. Shown in Figure 24b is a C-scan of the lower half of a typical damaged specimen. Notice the extent

of the damage area which is contained within about a hole radius. In Figure 30a we show a typical section through this damaged area. Here the interior  $0^\circ$  layers show several inclined narrow zones of fiber breaks, identified as *Fiber Kink bands*. A typical complimentary kink band is shown in Figure 30b. We note here a kink band inclination of  $65^\circ$  to the load carrying direction. The lengths of the fibers in the inclined zone measures to 50-84  $\mu m$ . More importantly it is pointed out that the region between the inclined zone appears undamaged and oriented parallel to the fiber direction. The geometry of the kink band is summarised in Figure 31. In this figure we also include the notation used to describe a typical kink band from ref. 10. In that study carbon fiber bundles of width  $\approx 400 \mu m$  oriented in three orthogonal directions were set in a Graphite matrix and subjected to localised impact. Post-experimental examination revealed typical *kink orientation* angles  $\alpha$  of  $45^\circ - 60^\circ$  and kink boundary orientation  $\beta$  obeying  $\beta \approx \frac{\alpha}{2}$  for broad( $\frac{l}{d} \geq 0.1$ ) kinks. Here  $\beta$  is measured from the *perpendicular* to the fiber direction. For narrow kinks  $\beta$  was found to increase and  $\alpha$  random. Corresponding results in our study which fall into the category  $\frac{l}{d} \geq 0.1$  indicate  $\beta \approx 25^\circ - 30^\circ$  and  $\alpha \approx 15^\circ - 30^\circ$ . However, no definite trend between  $\alpha$  and  $\beta$  can be established. One difference in the present case is that the specimen are loaded well into a post damaged state as opposed to being unloaded just after initial damage.

Figure 24. C-scan of damaged specimens

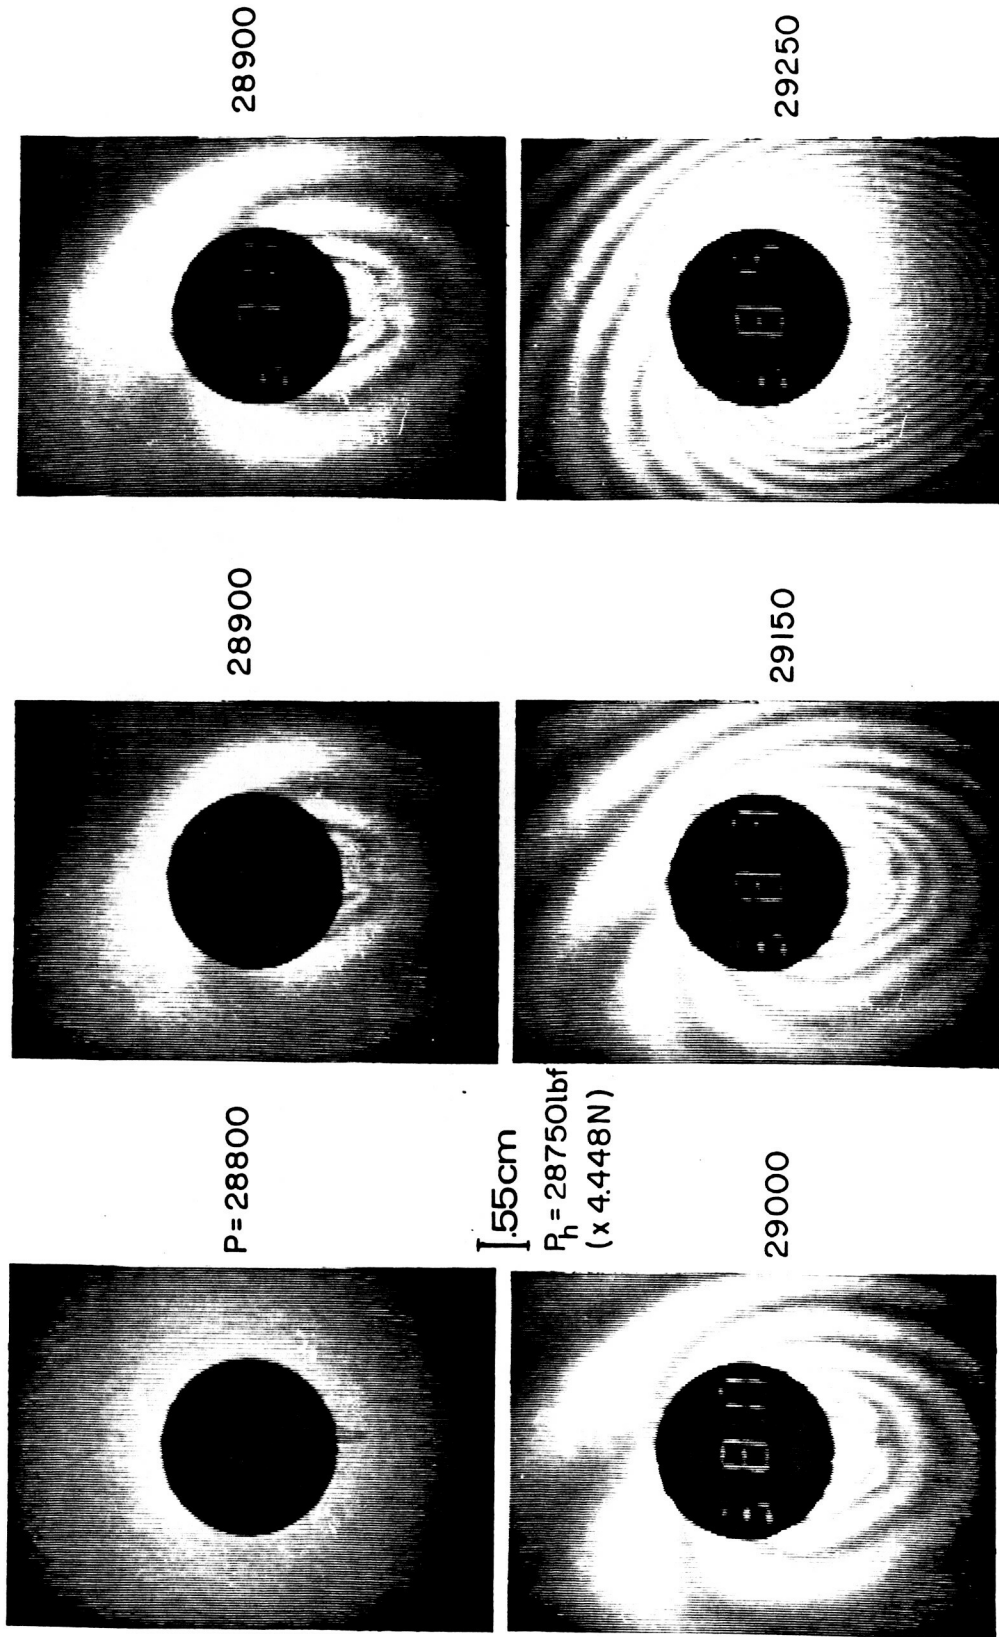
Figure 25. Surface buckle formation on lower half of spec. TB 17

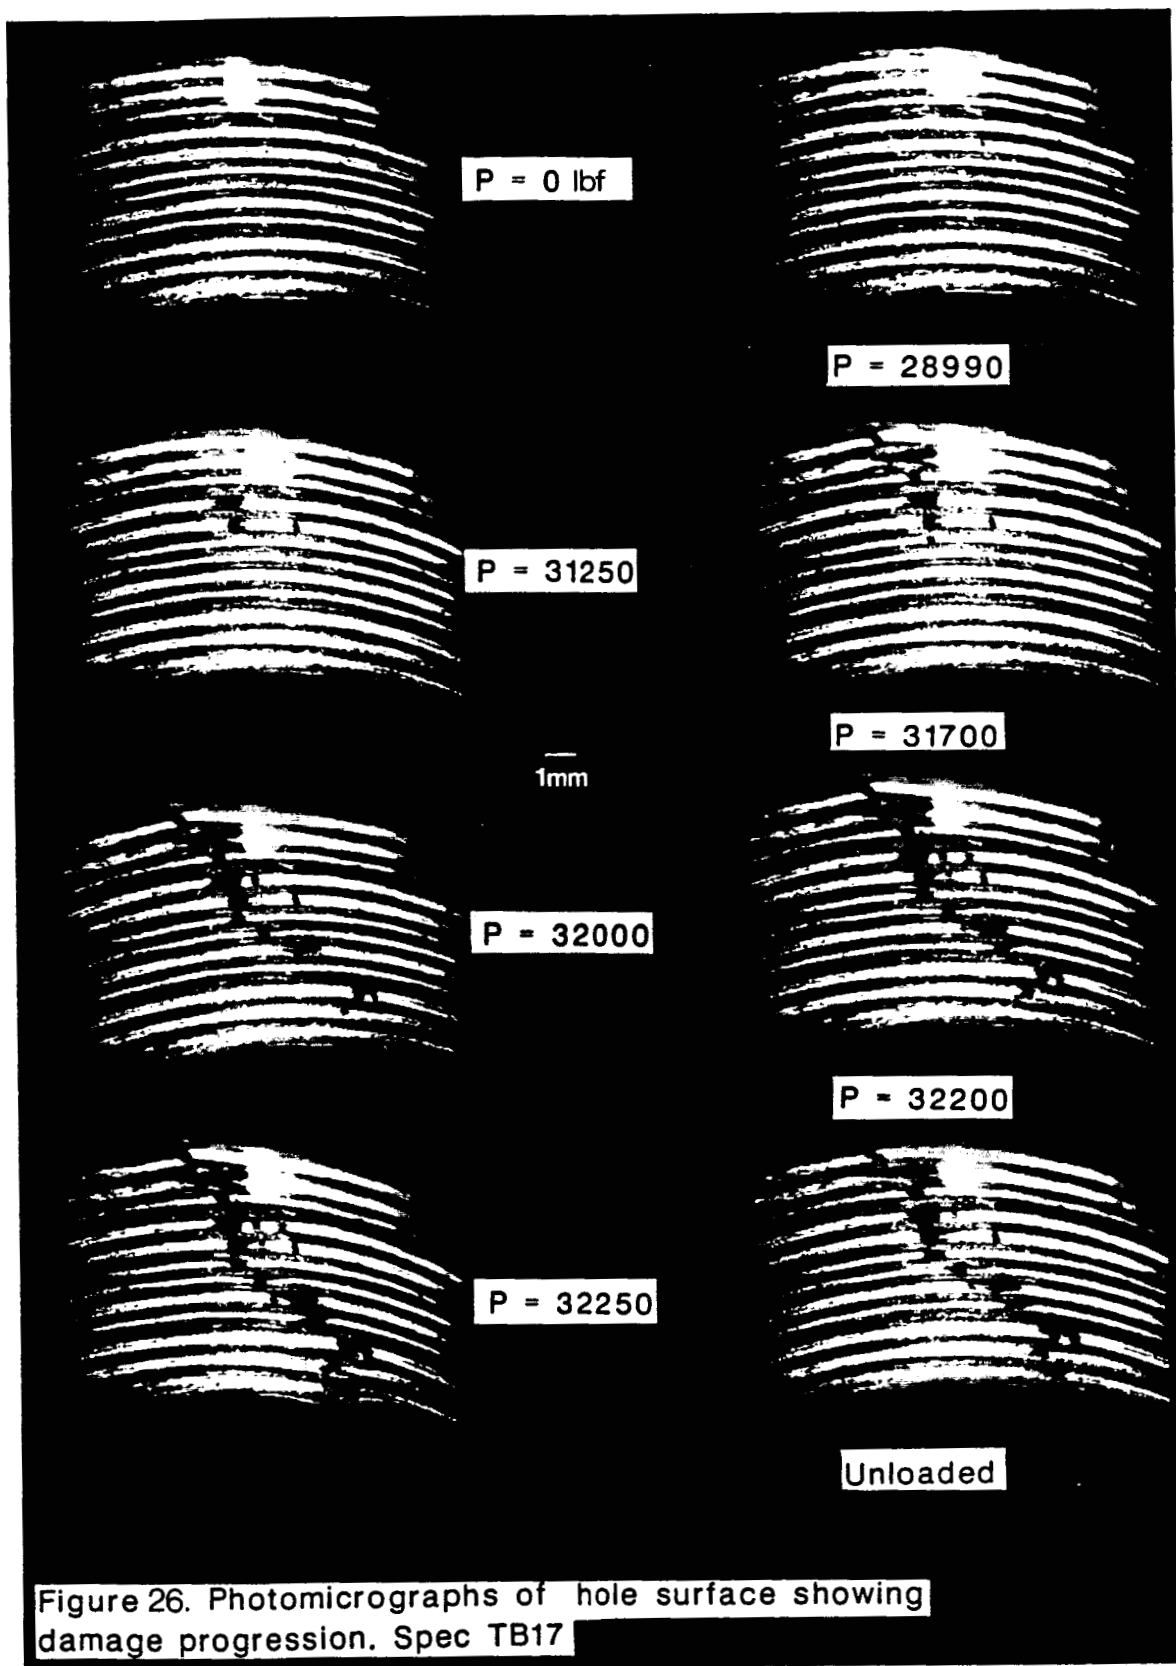
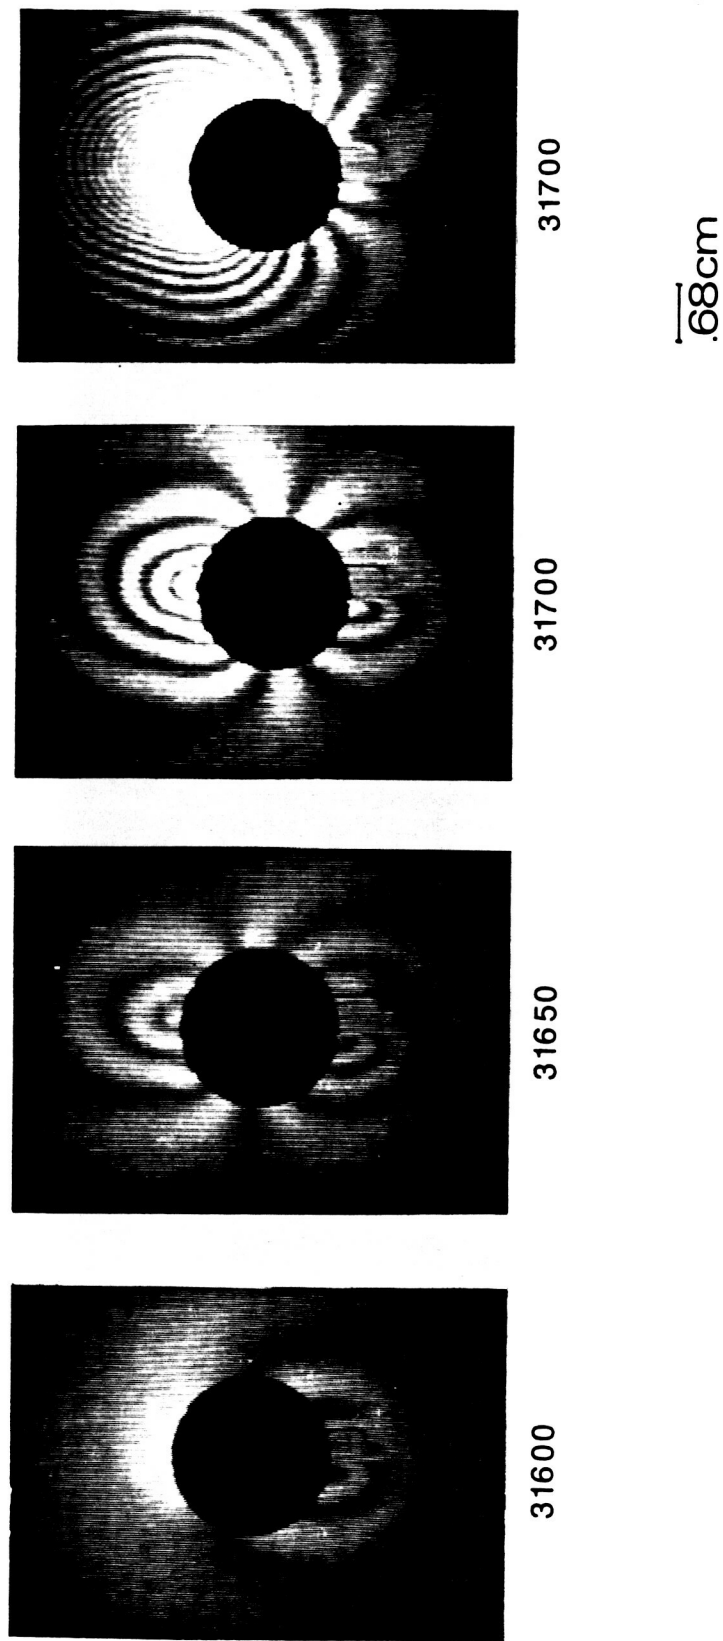
Figure 27. Initial buckling of surface delamination. ( Spec TB17 )  
duration between last two frames is 0.1 sec.

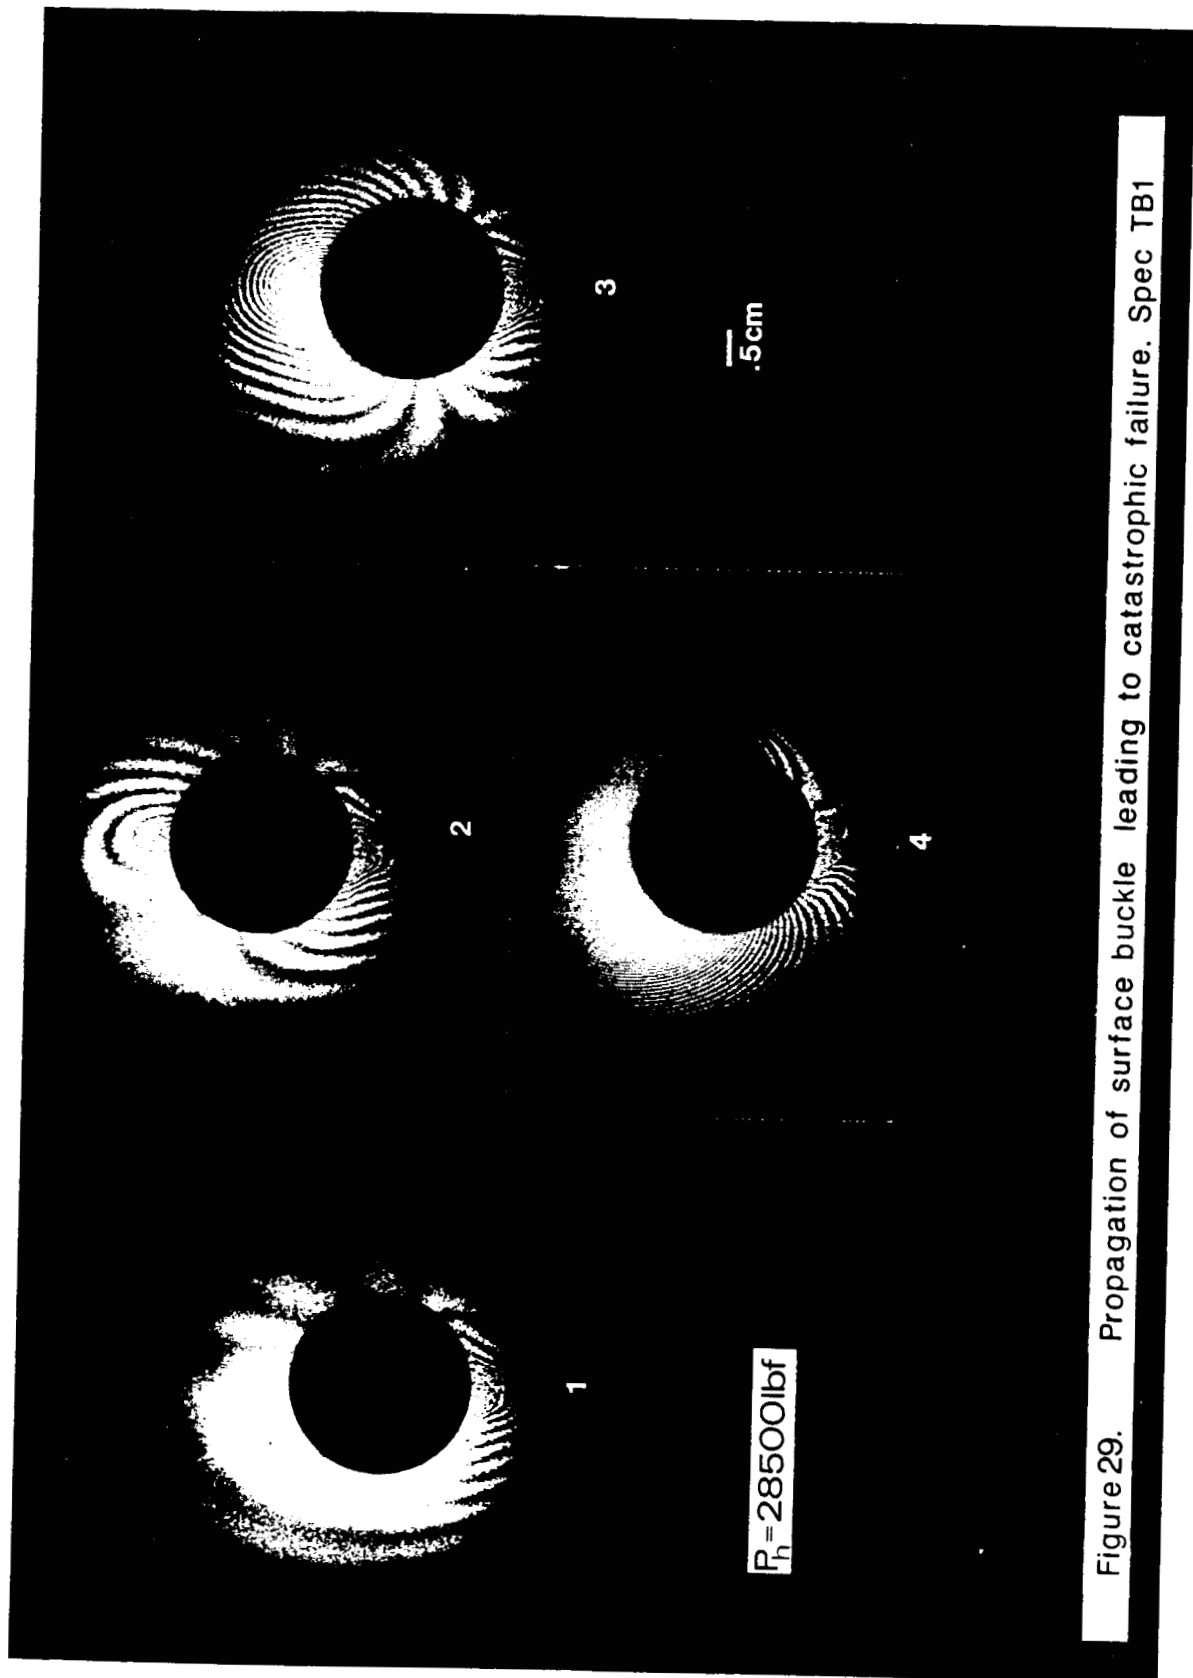
Figure 29. Propagation of surface buckle leading to catastrophic failure. Spec TB1

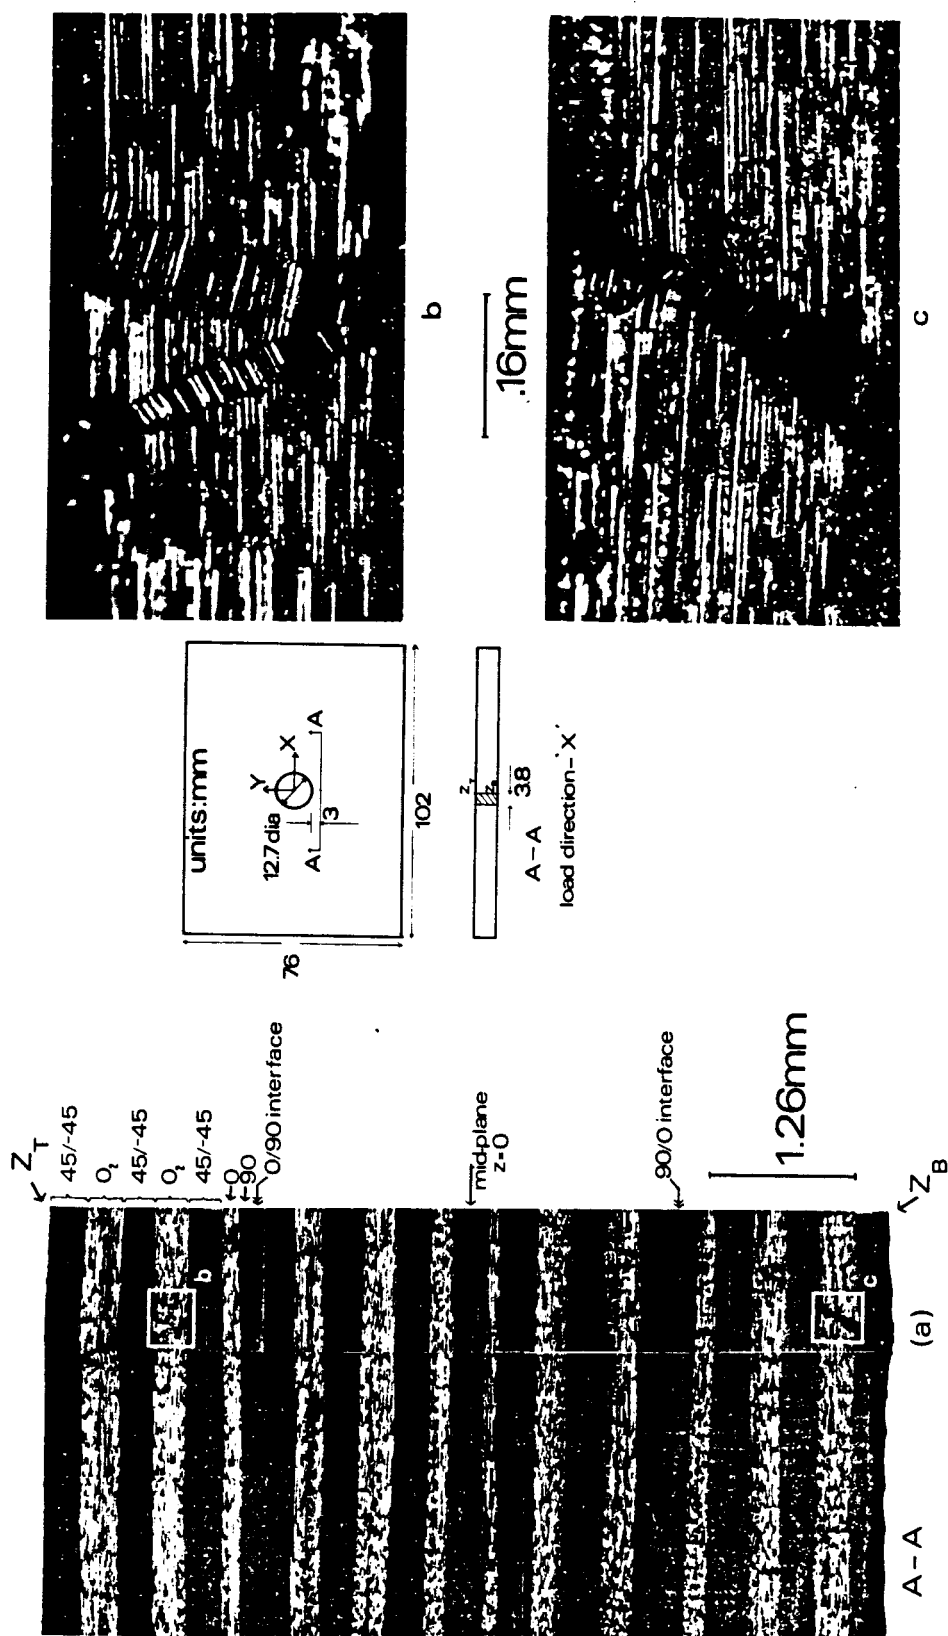
It was seen earlier that the outermost layers of the laminate that underwent large displacements in the buckling process suffered fiber breaks. A magnified view of such a fiber break is shown in Figure 30(c). It was of interest to examine the propagation of the initial fiber kinking failure into the interior of the specimen. This was done by sectioning at several positions and following the damage of a typical  $0^\circ$  layer. The results thus obtained are shown in Figure 32. Notice that the appearance of the kink is unaltered at several different cross sections. Further, the

Figure 30. Internal damage at the vicinity of the hole.(spec. TB15) a) Entire cross-section. b) complimentary kink in second  $O'$  layer from top. c) magnified view of damage to bottom  $O'$  layer.

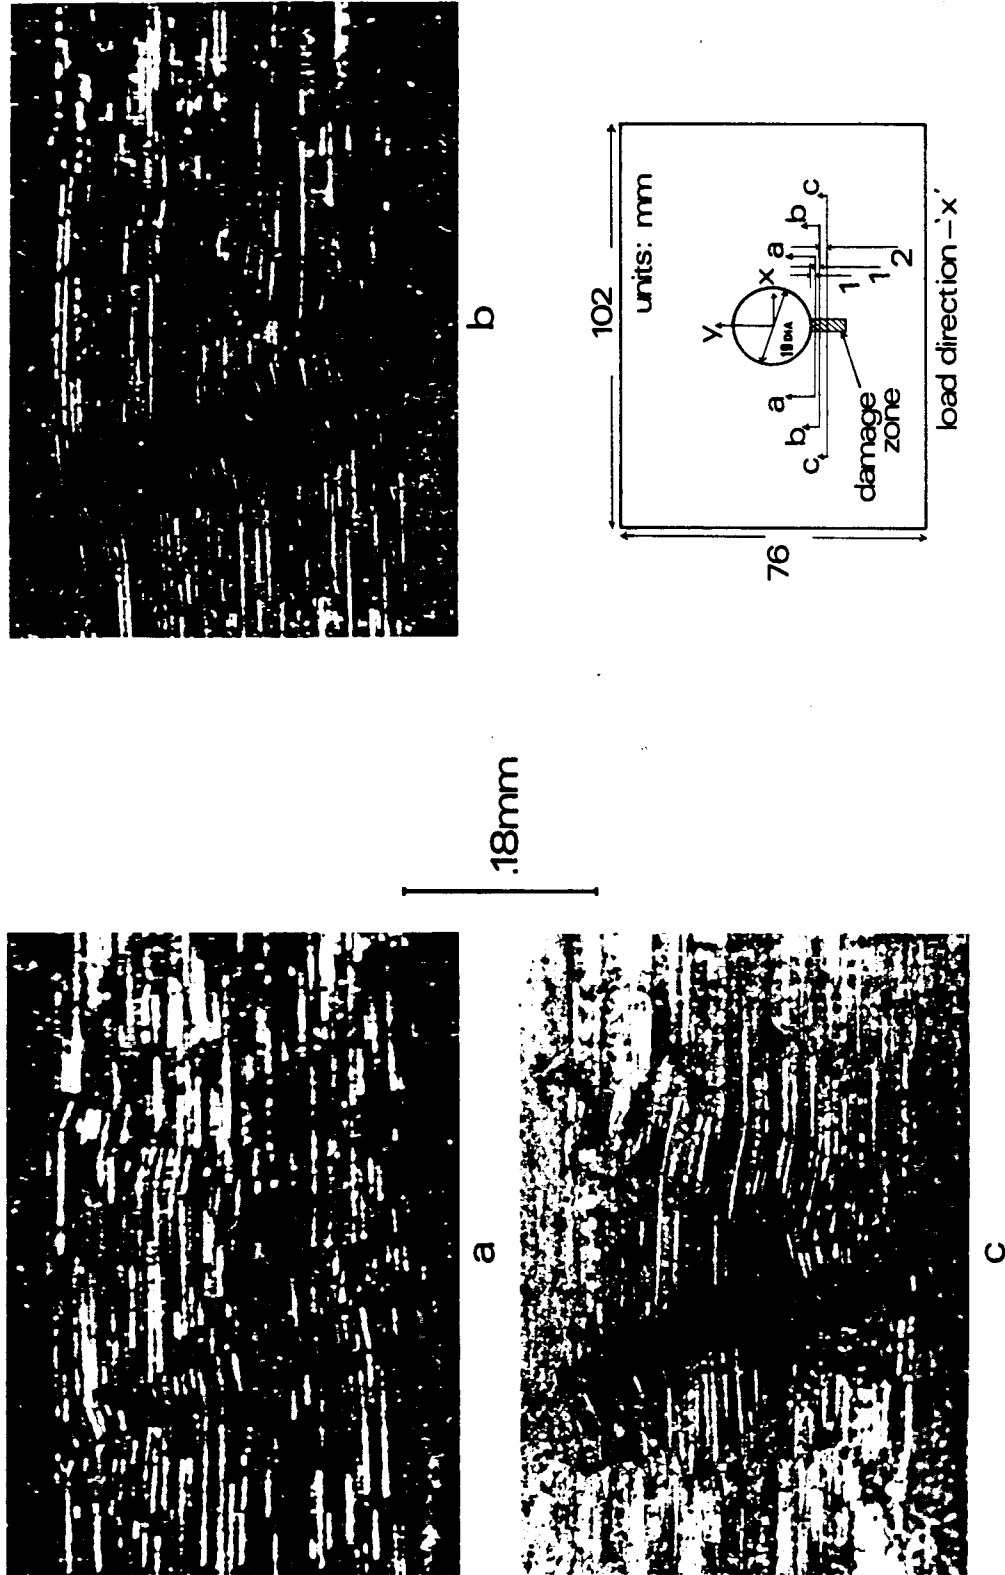
same type of geometry as found before is seen to prevail with an area of undamaged fibers between two inclined bands of damaged fibers which have undergone rotation in the  $XZ$  plane. The lengths of the fibers in the damage zone are comparable to those seen before. A planform view of such a damaged  $0^\circ$  layer is shown in Figure 23b and c. The damage zone width is approximately  $0.27\text{ mm}$  (38 fiber diameters). Here we note the fiber jutout failure at the edge of the hole. The damage zone appears dark as the fibers in this area which are broken and kinked out of plane were polished off during preparation of the specimen for microscopic examination. Finally in Figure 33 we show the outer layer delamination crack at two different cross-sections.

Figure 32. Kink band appearance at different cross sections.(TB17)
